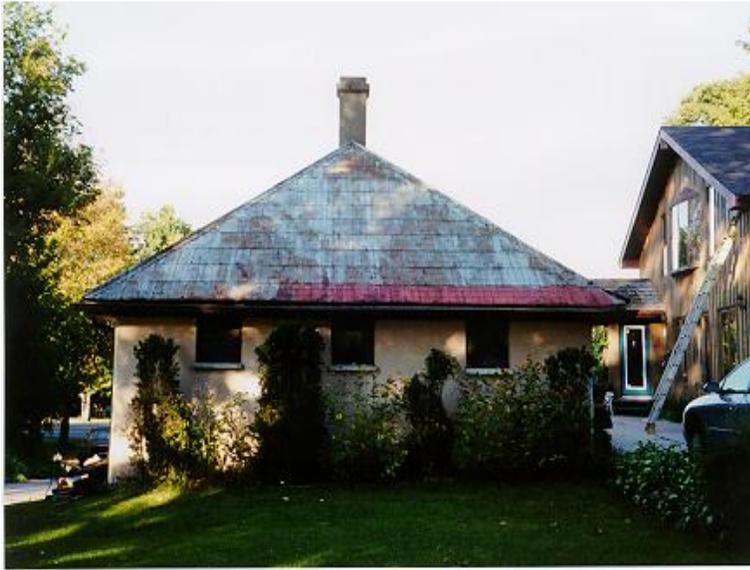
The lockup is fabricated in an aggregate of stone, brick, and concrete, and measures about 20x28 feet. The hip (cottage) roof is clad in pressed metal sheets with folded and raised metal ridges. A chimney stack is placed slightly to the west of centre to serve a wood burning stove. The aluminum soffits and metal gutter system are not original. The exterior is plaster clad, and has been over-coated with similar materials and paint.

The main entrance is centrally placed on the east facade. The door is tongue and groove, V-jointed wood, clad on one side with metal sheeting, and secured by a surface mounted lock.

A flat window opening with a 1x1, double hung sash is on the north facade, at the east. It is not known if this sash is original. There is a similar window opening on the south facade, with a replacement sash.
